**PRE-MEETING AGENDA
MOUNTAIN BROOK CITY COUNCIL**

YARD INLET 2 → OUTFALL

3811 River View Circle

Emergency Pipe Repair.

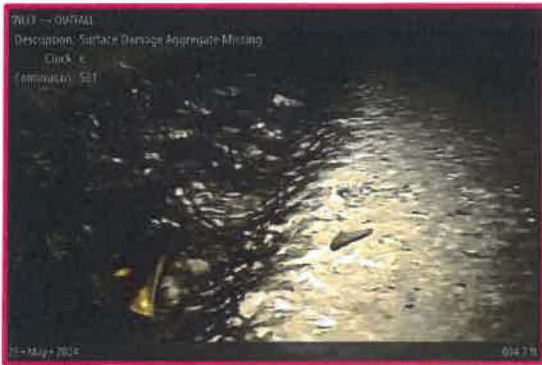
[Grade 4] Surface Damage Aggregate Missing (start) at 000.1 ft, 6 o'clock

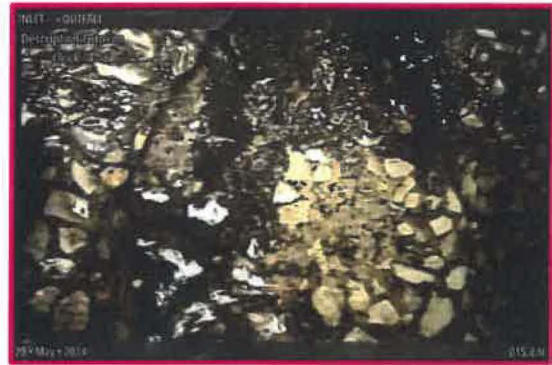
[Grade 4] Broken at 015.8 ft, 4 - 6 o'clock

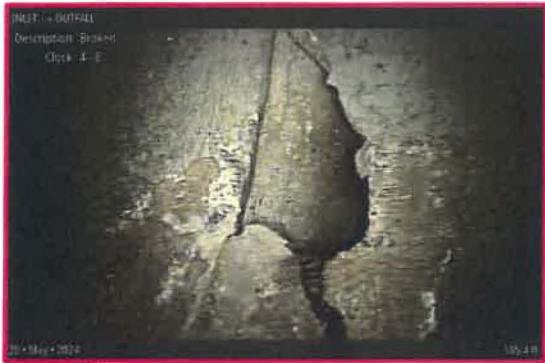
[Grade 4] Broken at 105.4 ft, 4 - 8 o'clock

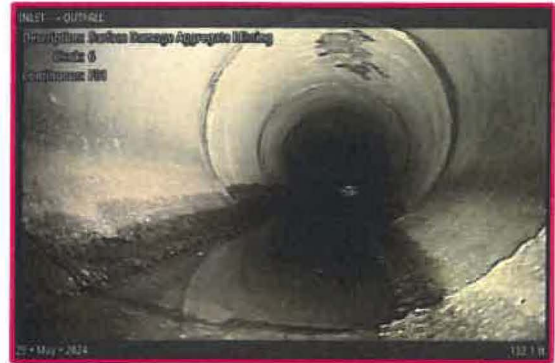
[Grade 4] Surface Damage Aggregate Missing (finish) at 132.1 ft, 6 o'clock

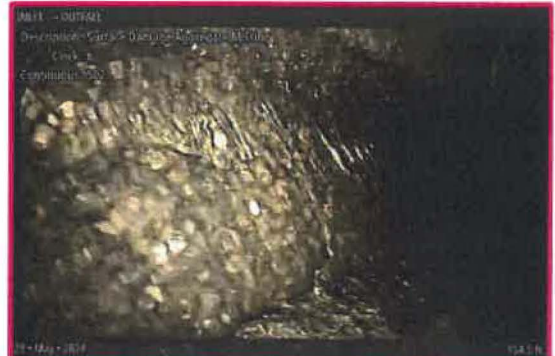
[Grade 4] Surface Damage Aggregate Missing (start) at 154.3 ft, 6 o'clock

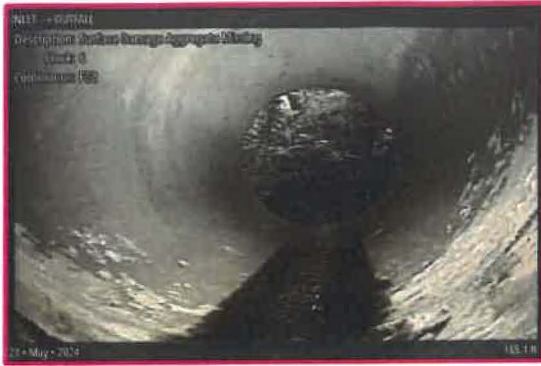
**[Grade 4] Surface Damage Aggregate Missing (finish)
at 185.1 ft, 6 o'clock**

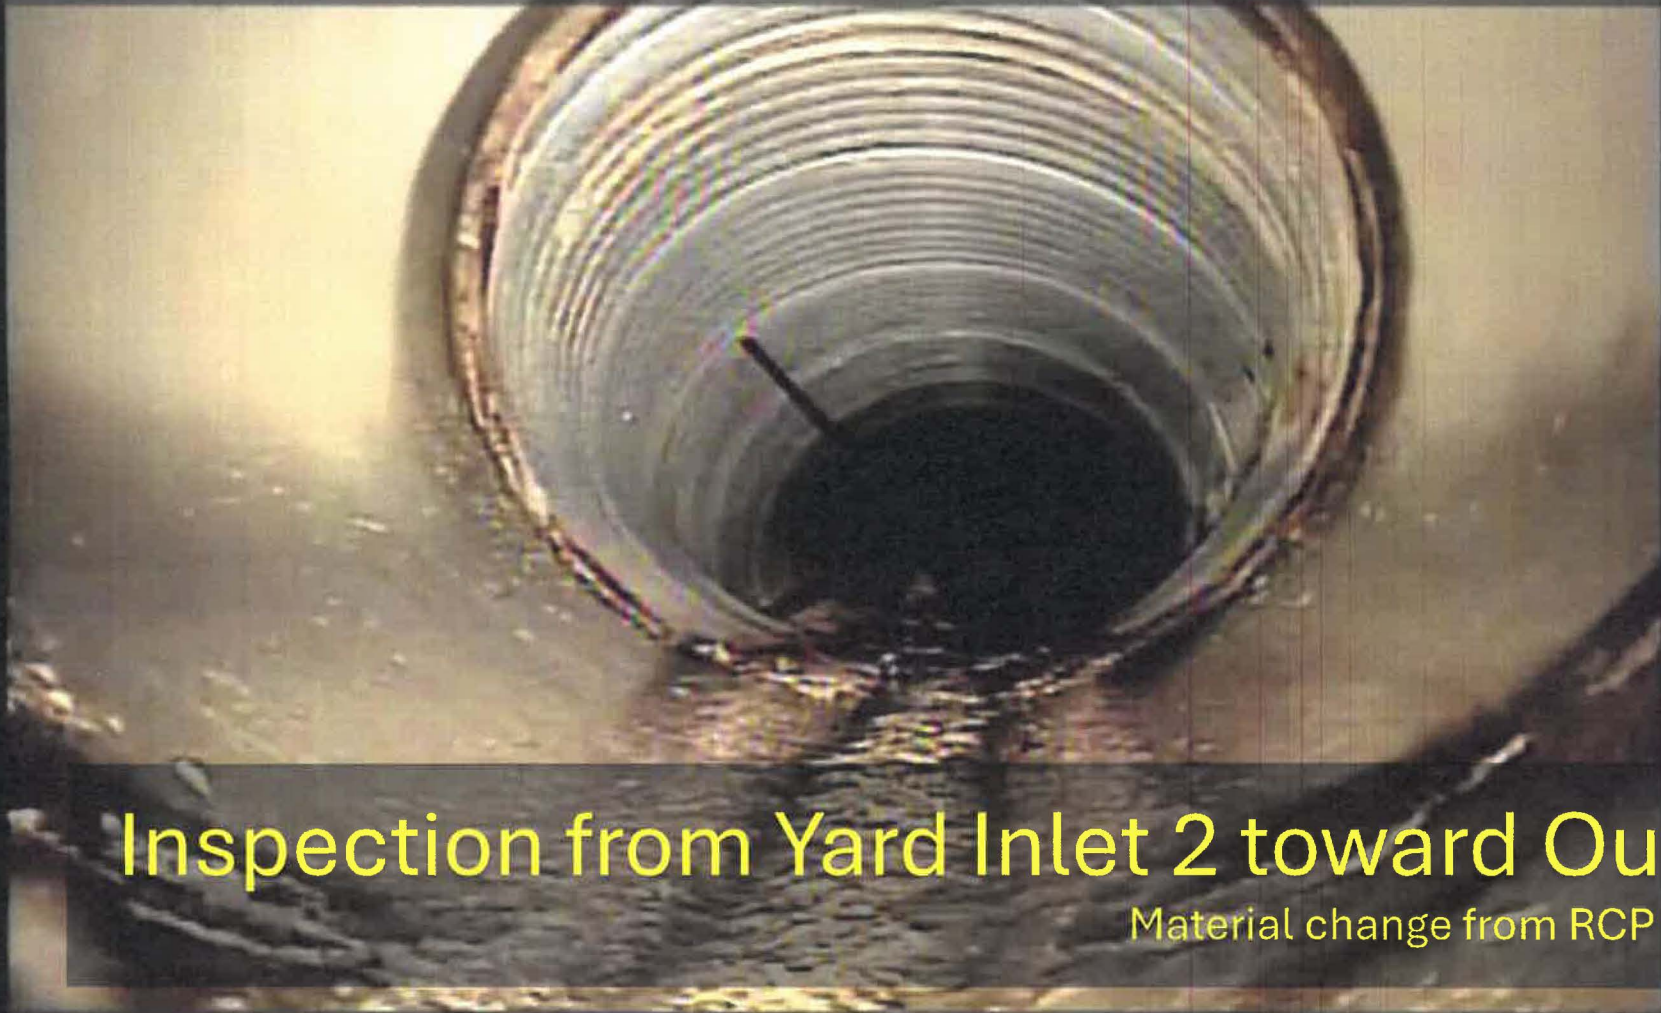
Material change from RCP to CMP.

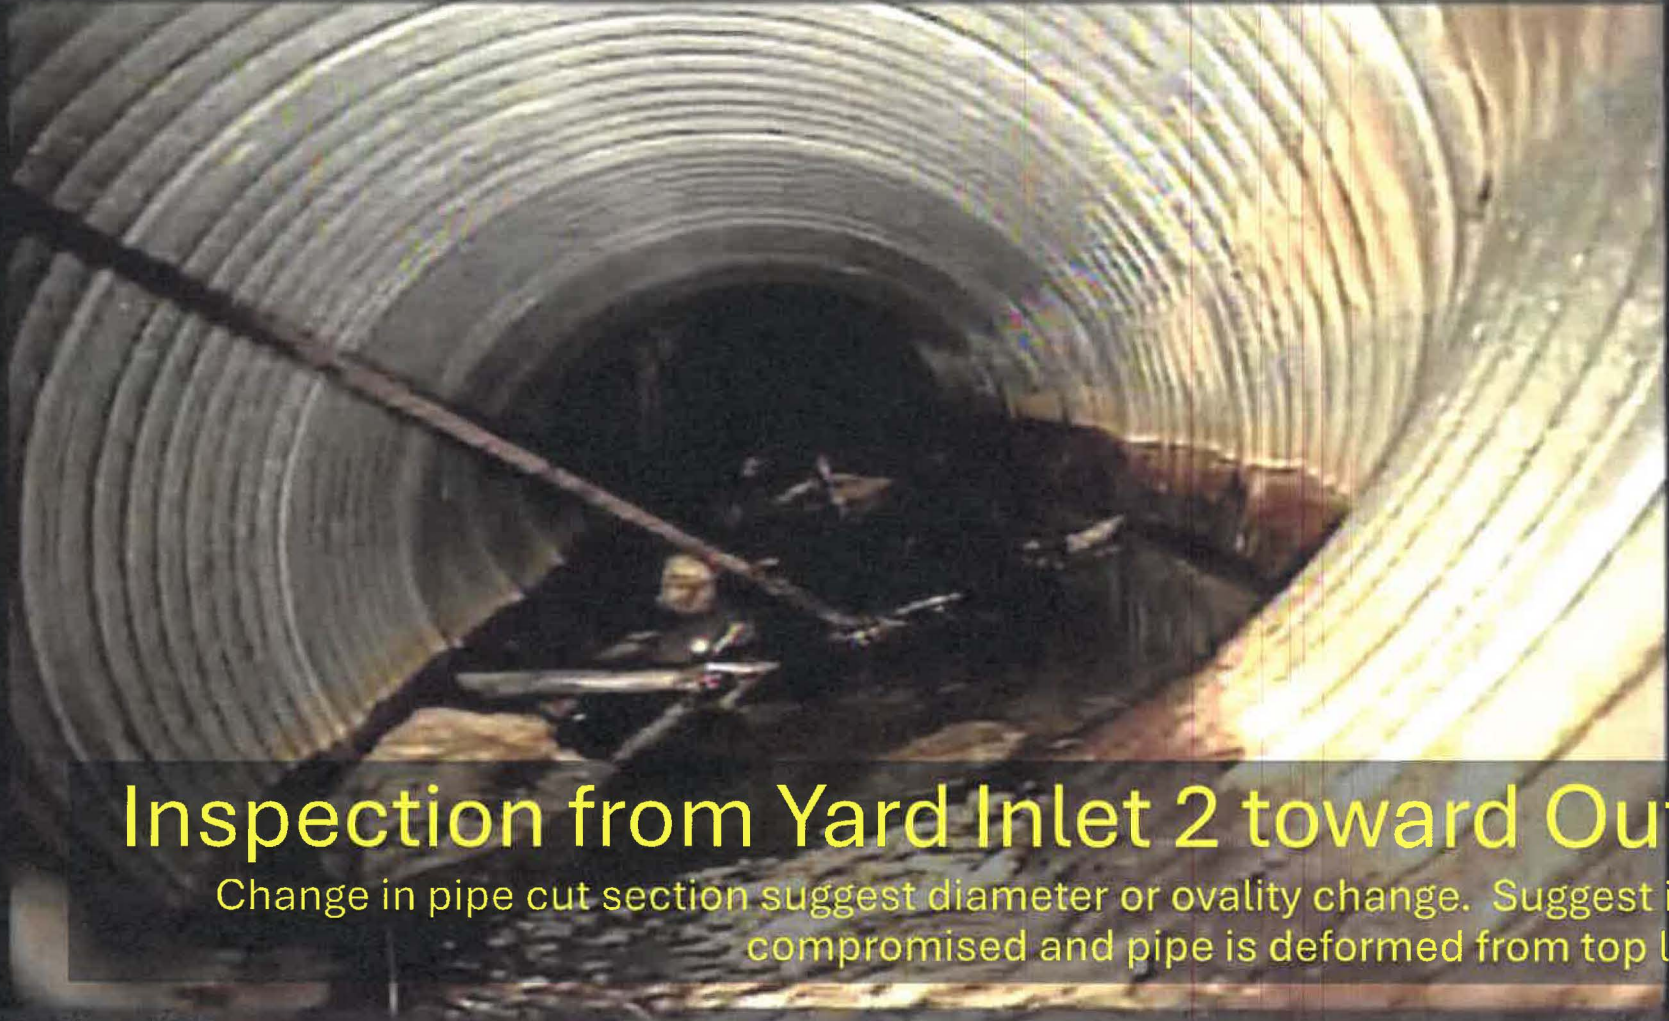
Change in pipe cut section suggest diameter or ovality change. Suggest invert is compromised and pipe is deformed from top loading.

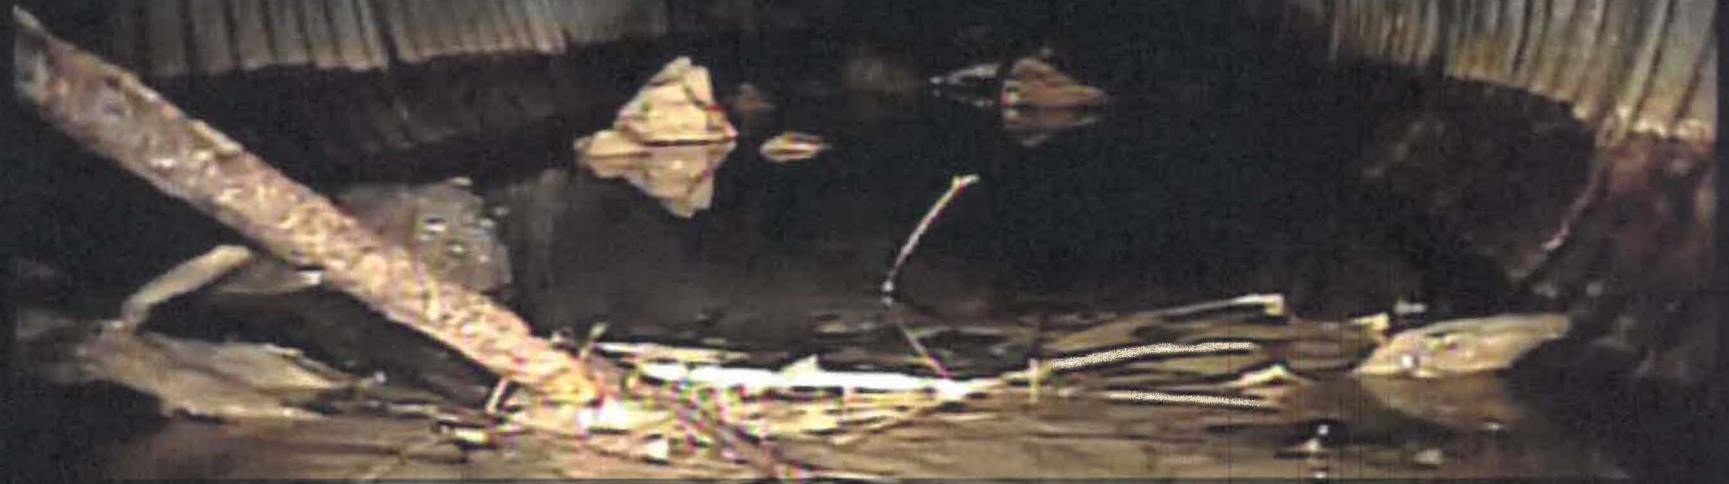
Rust line on pipe walls shows the galvanized coating removed. Views of exposed subgrade and invert condition further support a failed invert.

Description: Miscellaneous Survey Abandoned.
Remarks: UNABLE TO CONTINUE INSPECTION
DUE TO DEBRIS IN INVERT OF PIPE..

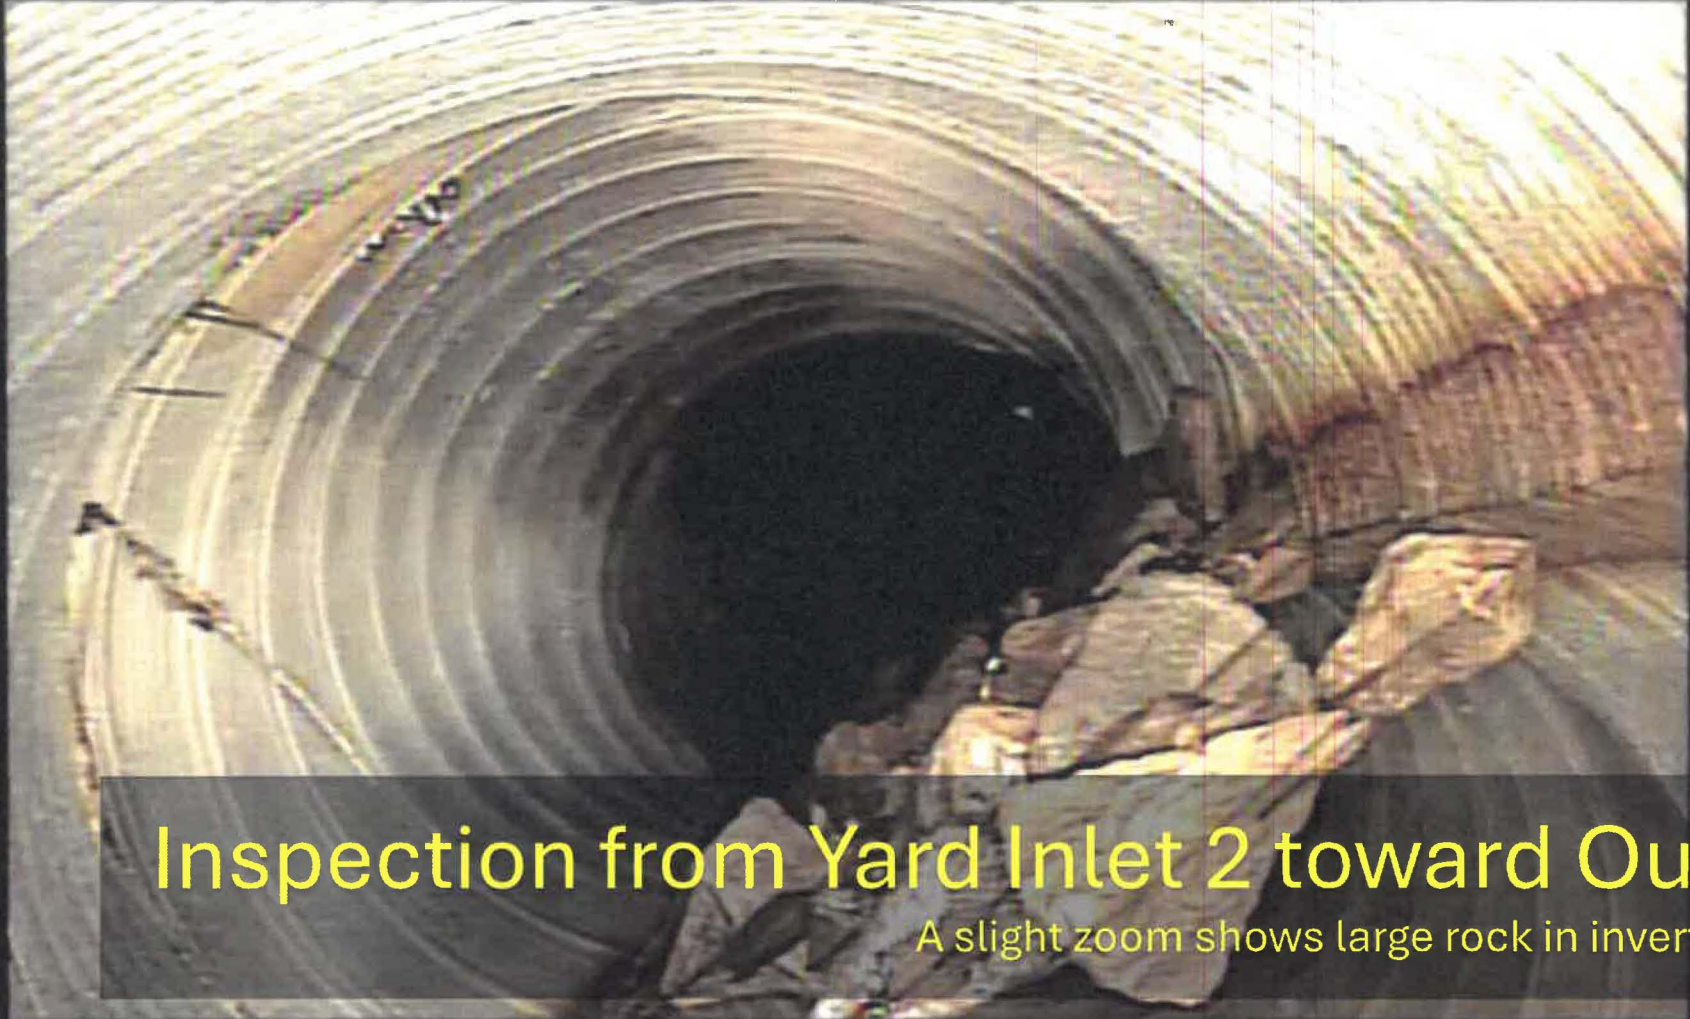
A slight zoom shows large rock in invert ahead.

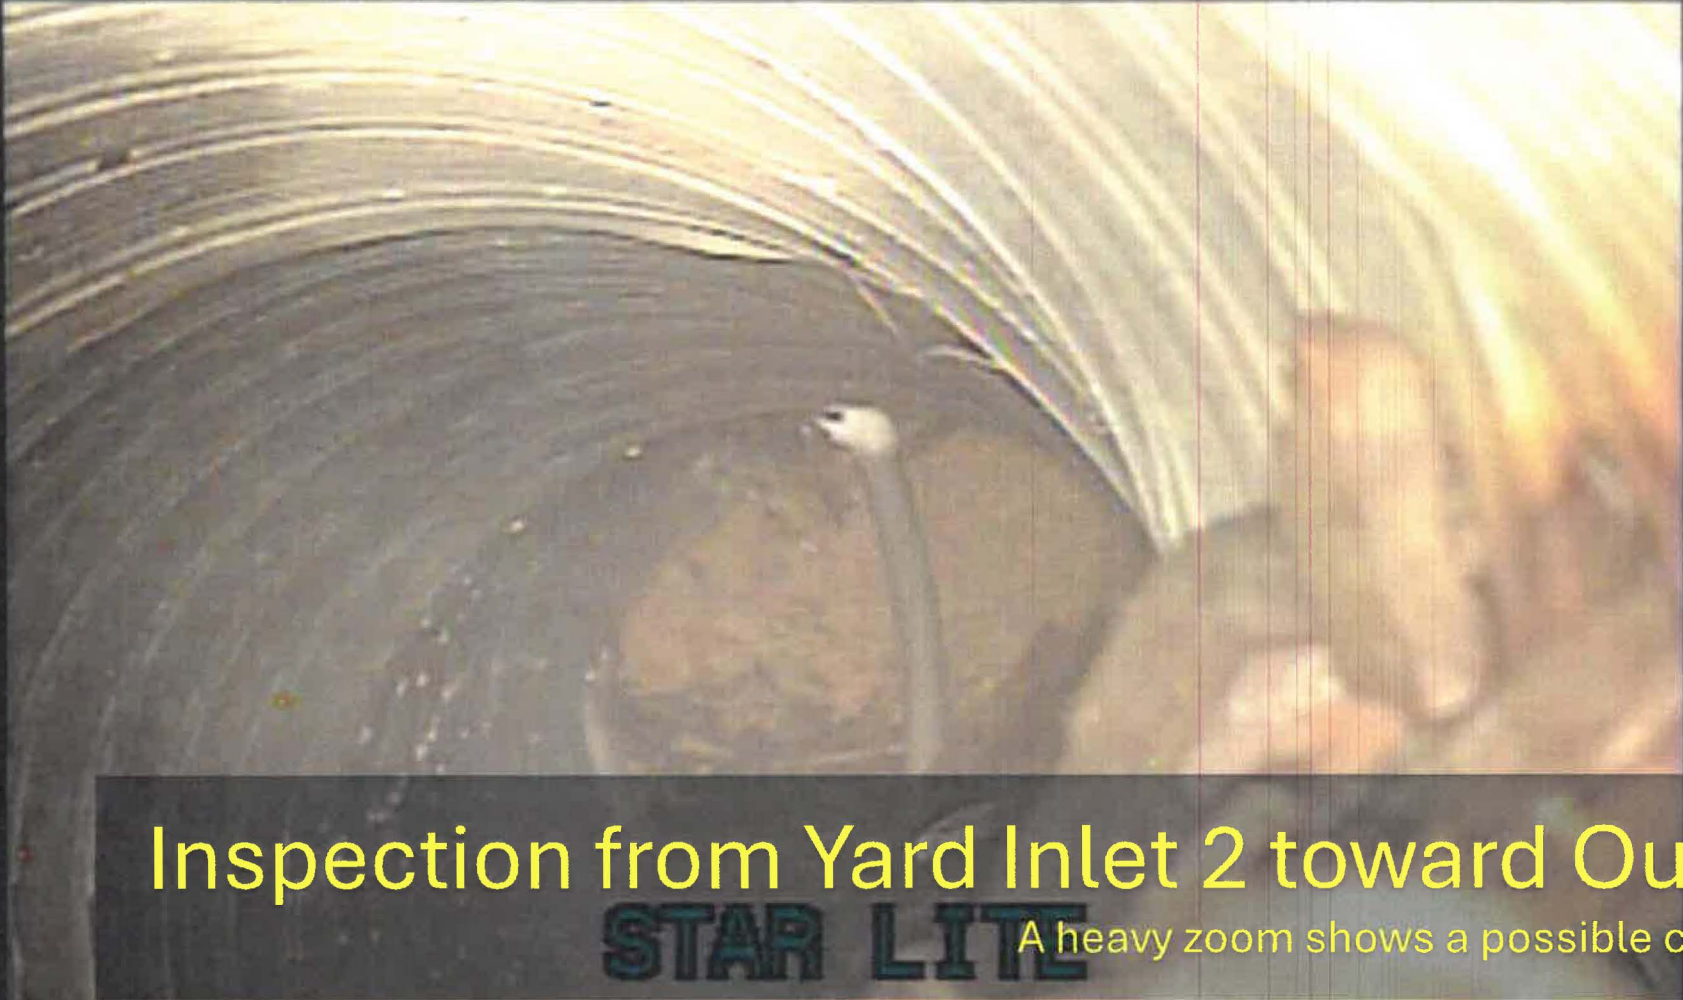
A heavy zoom shows a possible collapse.

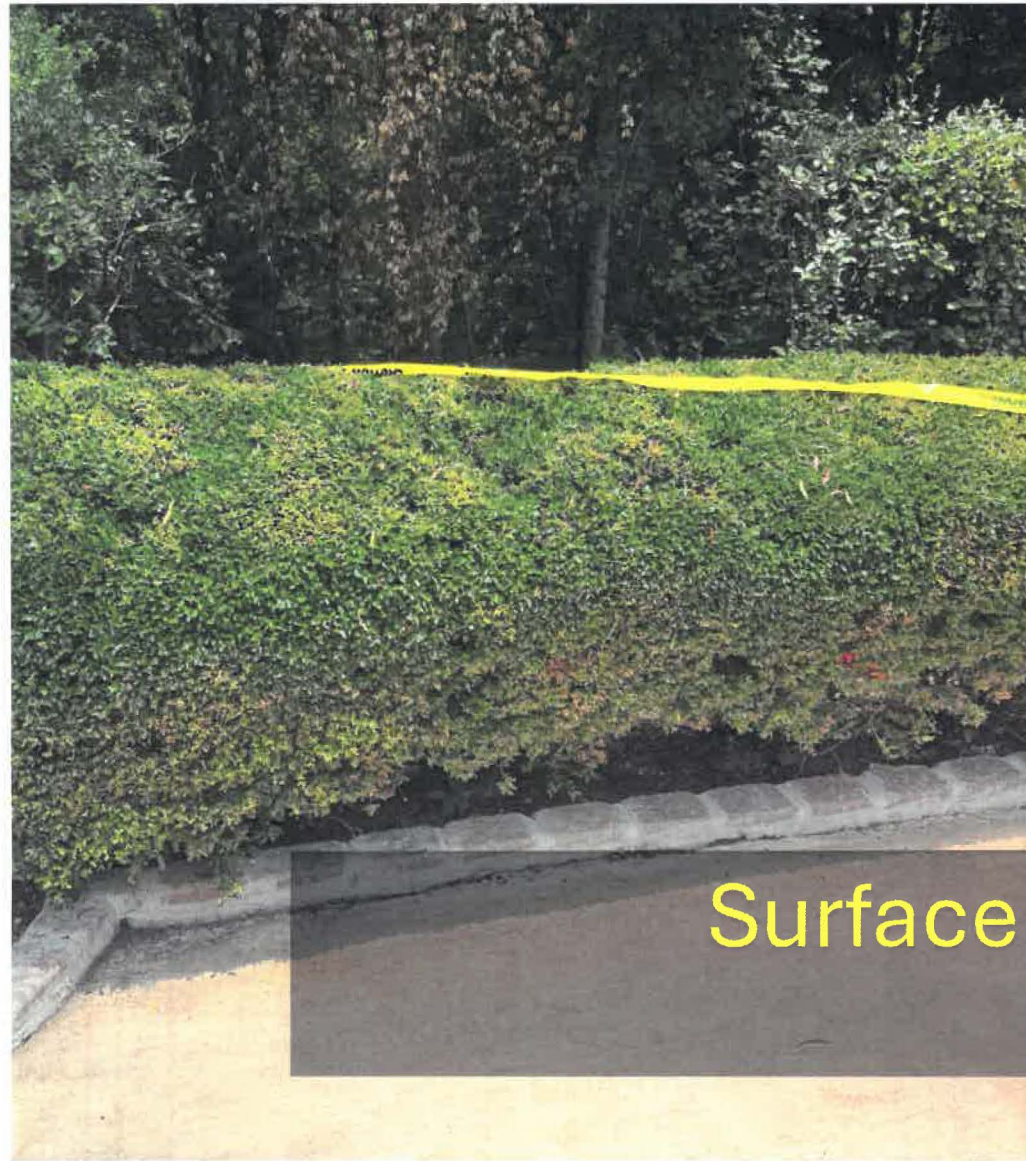
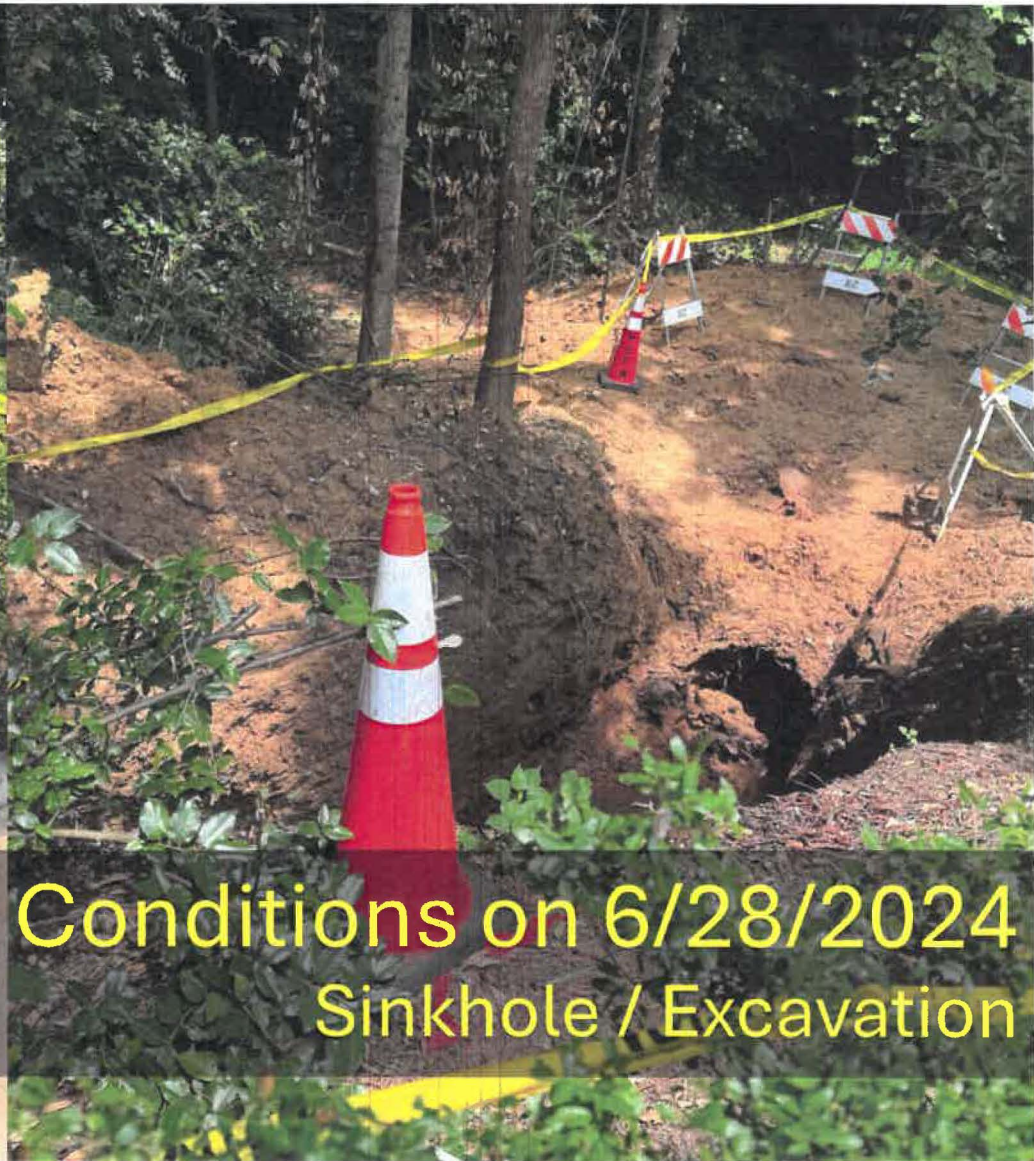
Surface Conditions on 6/28/2024
Sinkhole / Excavation

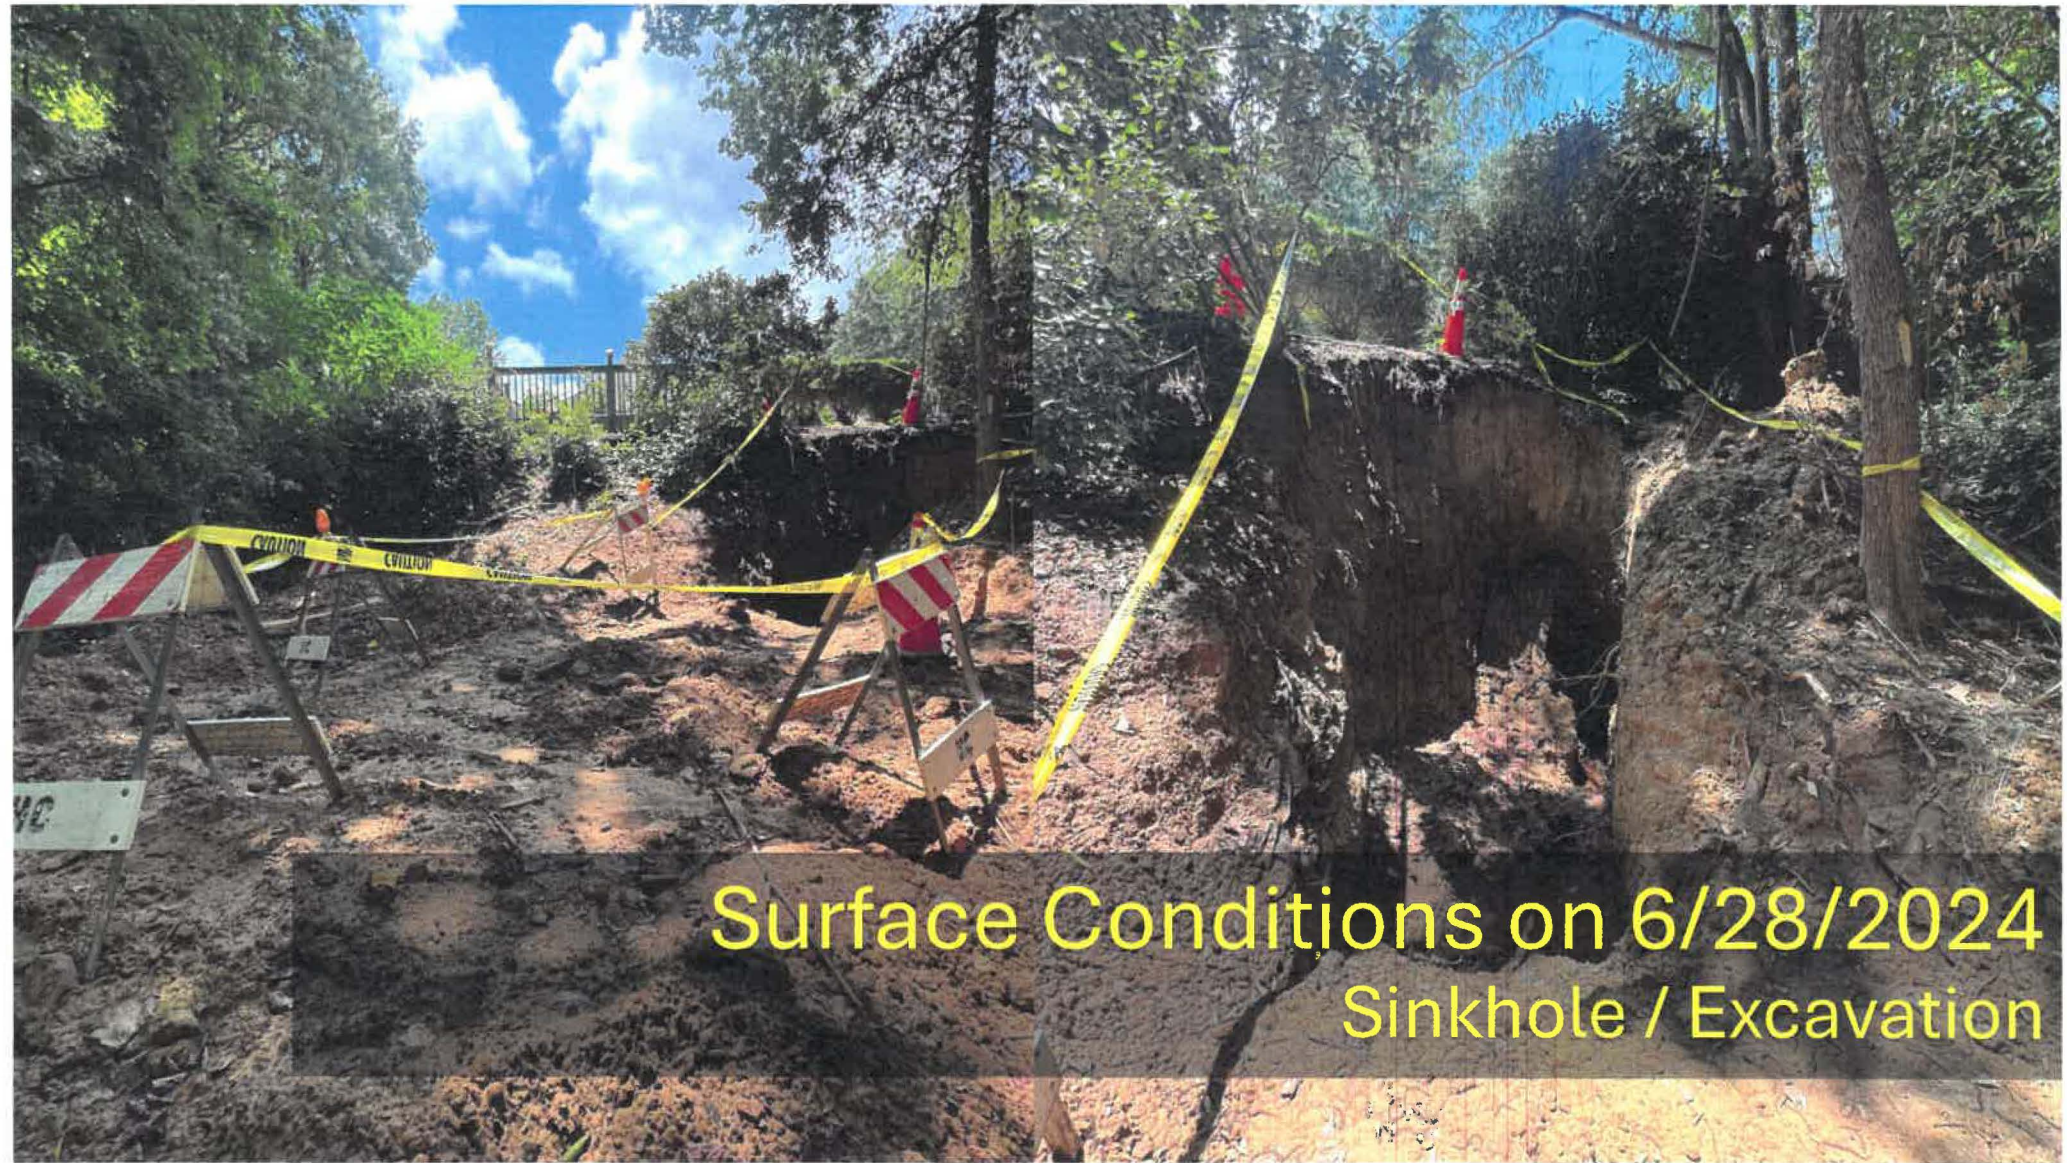
Surface Conditions on 6/28/2024
Sinkhole / Excavation

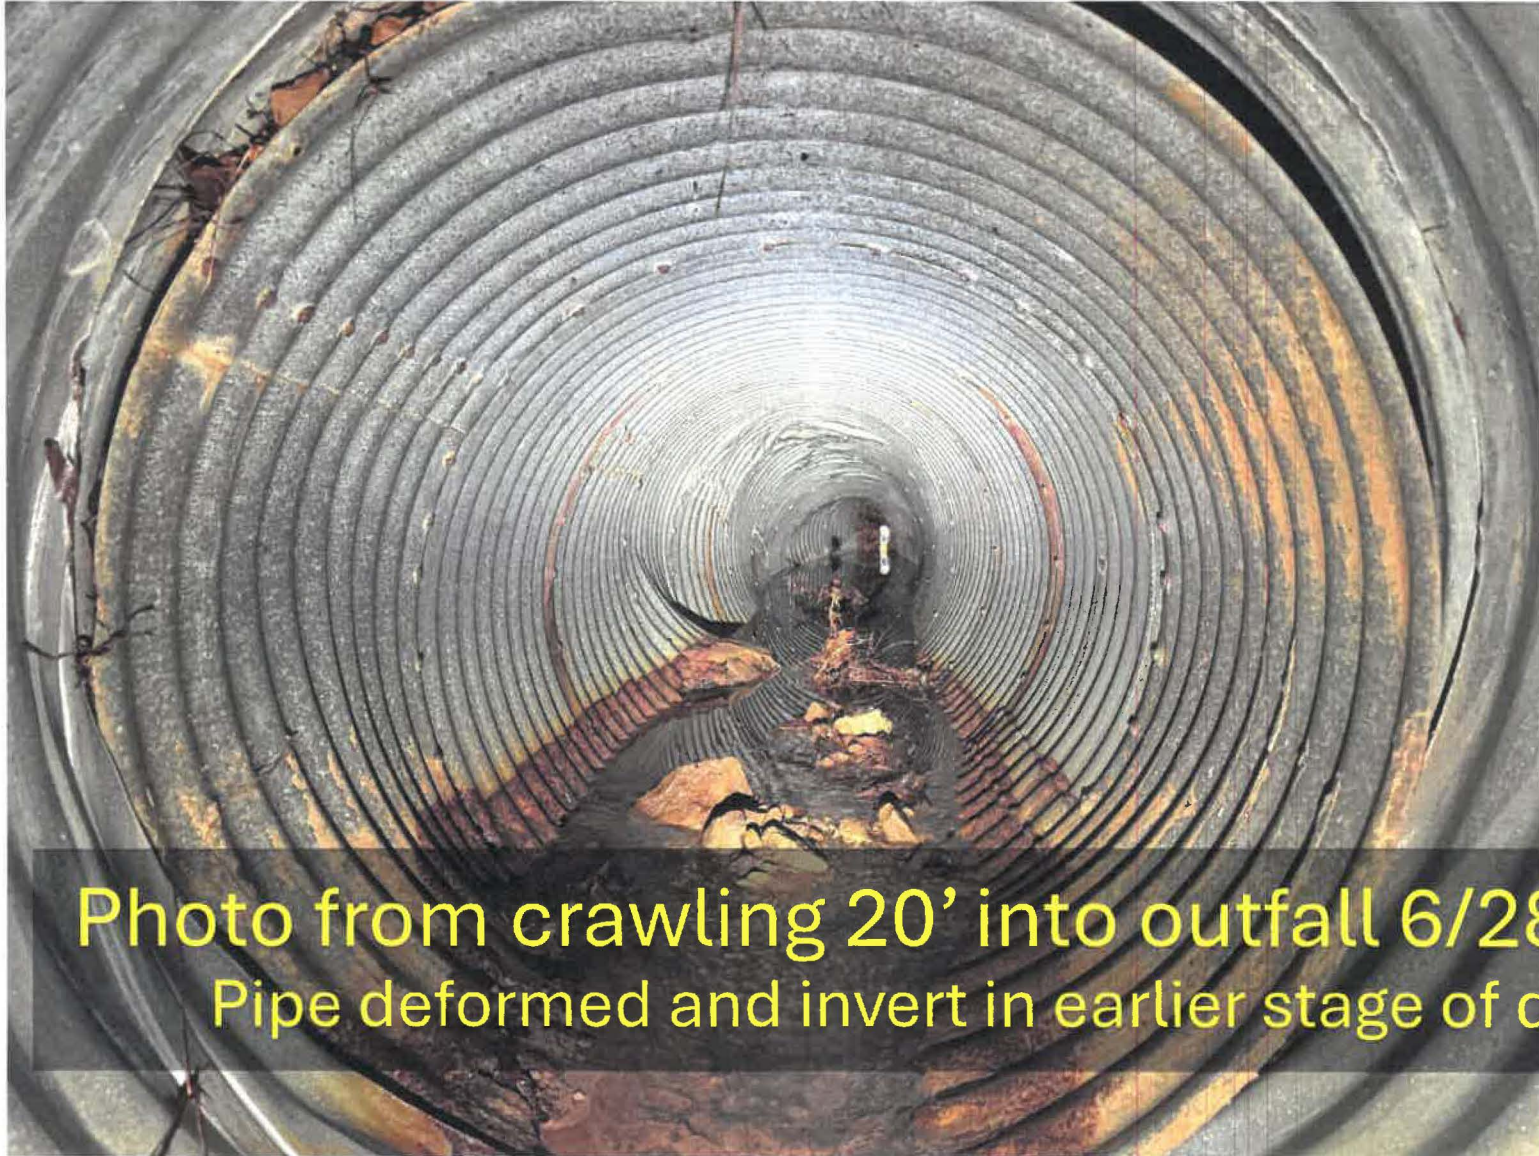
Photo from crawling 20' into outfall 6/28/2024
Pipe deformed and invert in earlier stage of decomp.

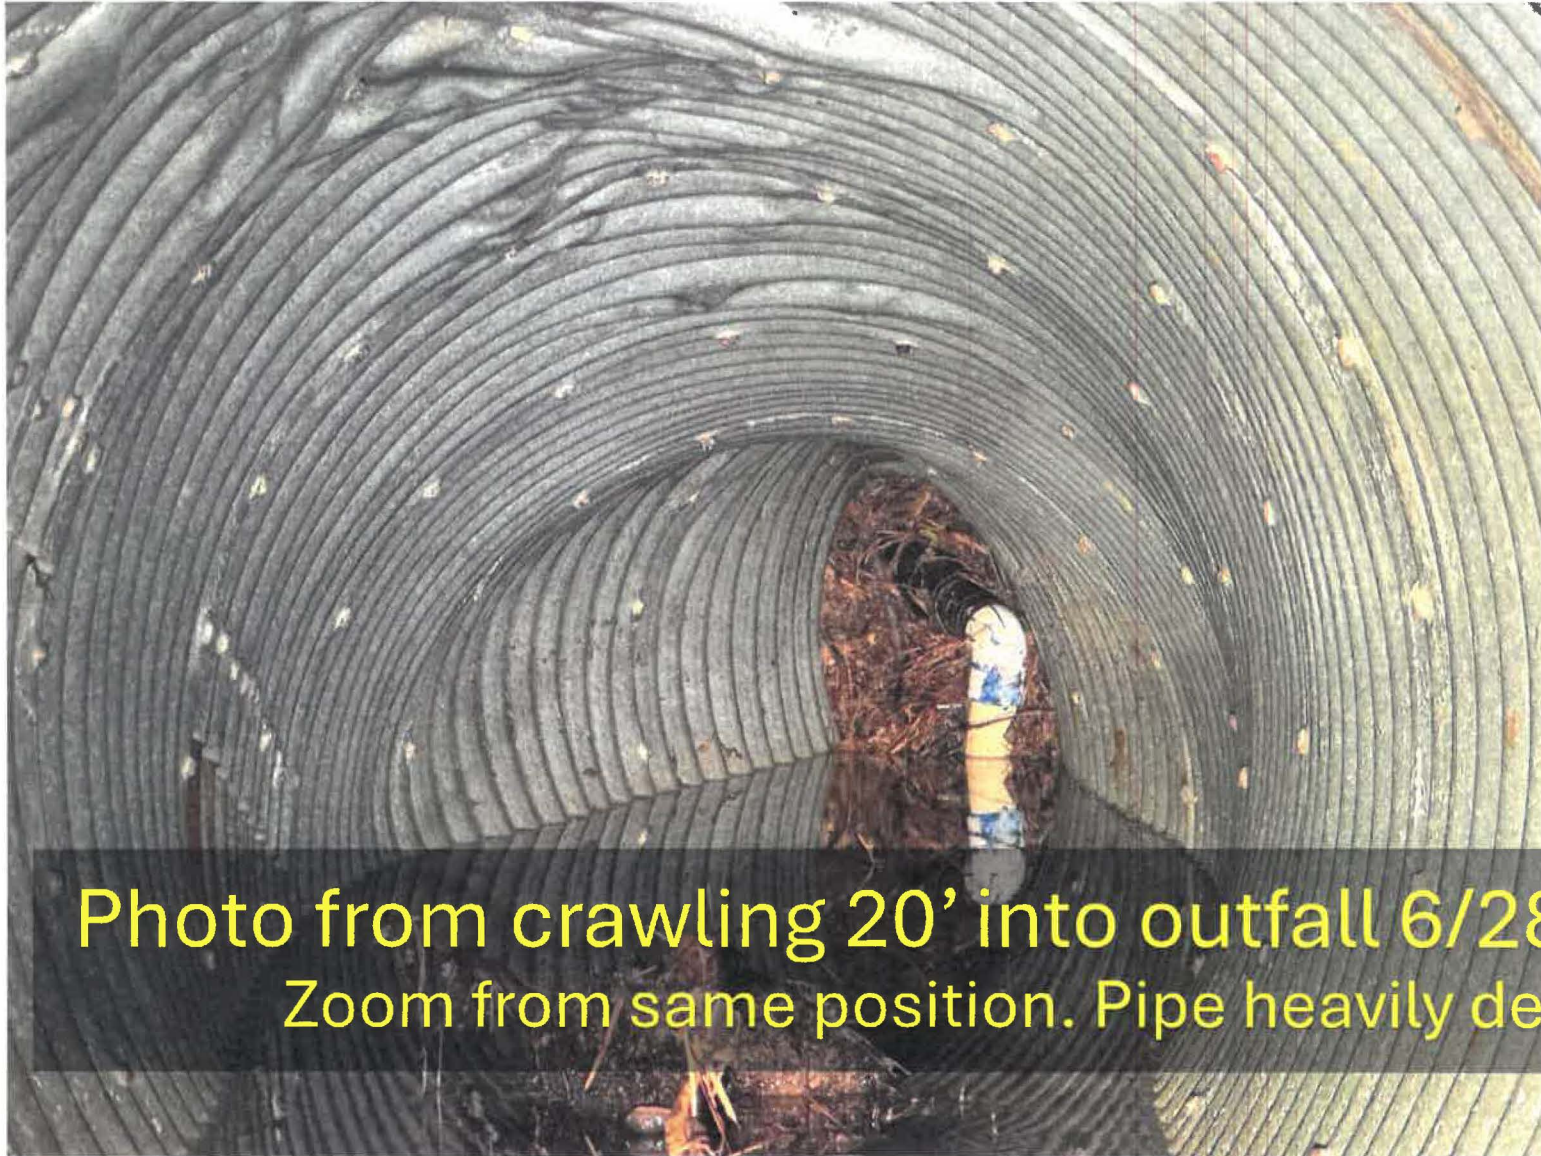
Photo from crawling 20' into outfall 6/28/2024
Zoom from same position. Pipe heavily deformed.

Approximately 70' from its discharge point, the pipe is severely compromised. Video and pictures confirmed that the pipe has experienced a failure leading to loss of surrounding soil and voids in the soil beneath the driveway. The condition of the pipe, as observed by the City and its contractors, is poor. The invert is severely corroded. This is highly suggestive that the pipe is in a state of ongoing failure and will continue to fail, given the depth of cover on it.

Based on the condition of the pipe and the near total blockage at least one point, the City determined that a non-invasive repair was not possible. The only reasonable remedy is to replace the pipe by open cut method. Schoel made a site visit on July 8, 2024 and concurs with the City's determination regarding the condition of the pipe and the option to replace the pipe.

1. Open cut, remove and replace the existing 36" corrugated metal pipe with approximately 170 lf of 36" RCP
 - a. Install new precast headwall at the discharge end of the new pipe
